STATE OF CALIFORNIA  
DEPARTMENT OF PUBLIC WORKS  
DIVISION OF HIGHWAYS

DYNAMIC FULL SCALE IMPACT TESTS  
OF  
CABLE TYPE MEDIAN BARRIERS  
TEST SERIES VII

MARCH 1964

Proj. W. O. R-62280  
Hdqtrs. W. O. 62-19U51H21

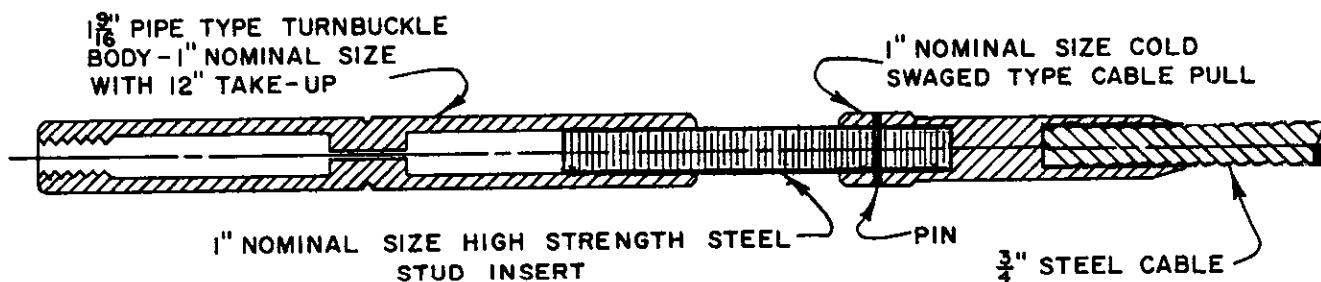
## C. PIPE TYPE TURNBUCKLE USED IN SERIES VII

The same four pipe-type turnbuckles (Exhibit 3-C) were used for all four of the barrier tests, 2 in the impact zone and 2 at the end anchor (see Exhibit 6). The only damage sustained was three bent studs that required replacement. For each of the tests two of the turnbuckles were positioned ahead of the point of impact so that the efficiency under the following conditions could be observed: (1) breaking strength under direct loading, (2) passing of the turnbuckle assembly through the vehicle body without entrapment, and (3) passing of the stripped cable clamps over the body of the turnbuckle without jamming.

1. The pipe-type turnbuckle passes smoothly through the vehicle with no tendency to catch on any portions of the body.
2. There was no evidence of failure of either of the turnbuckles, even after 3 direct impacts at 83 to 90 mph.
3. The bent studs damaged during Tests No. 2 and 3 (Exhibits 10-B and 11-C) were easily removed and new studs replaced in a minimum of time and with a minimum of effort.

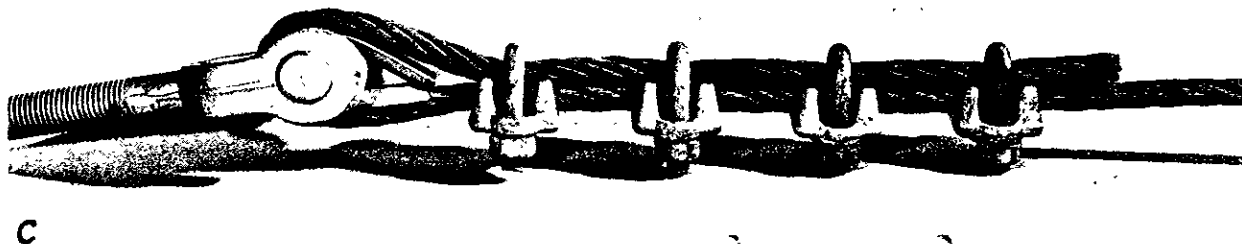
C. Proper Method of Clip Installation.

**PERFORMANCE:** (See Exhibit 15). All wheels remained on the pavement throughout the run. Smooth deceleration to a 180 deg. spin-out at 200 ft. from impact. The Crosby clips were installed backwards on one cable. The cable slipped two feet during the impact (see Exhibit 11-B).

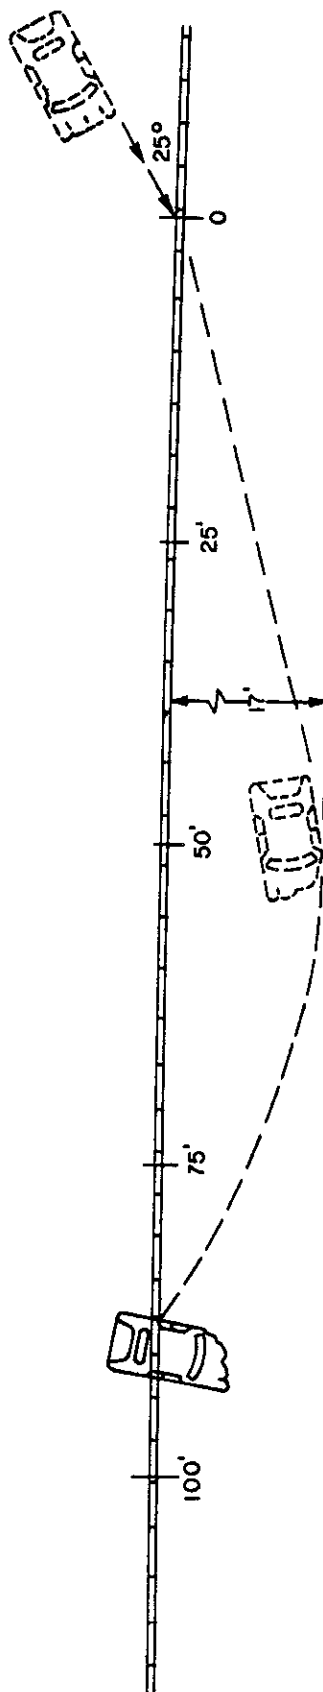
TEST NO.-----1  
 DATE-----8-9-62  
 VEHICLE-----1960 Dodge Sedan  
 SPEED-----90 MPH  
 IMPACT ANGLE-----25°  
 VEHICLE WEIGHT-----4300 lbs (W/Dummy & Instrumentation)

FENCE DAMAGE-----320' Anchor pulled from ground  
 CABLE DAMAGE-----Slight fraying  
 POST DAMAGE-----39 posts bent-25 beyond repair  
 POST ANCHOR DAMAGE-----19 Cracked  
 MAX. DEFLECTION OF CABLES-----17'  
 VEHICLE DAMAGE-----\$ 600

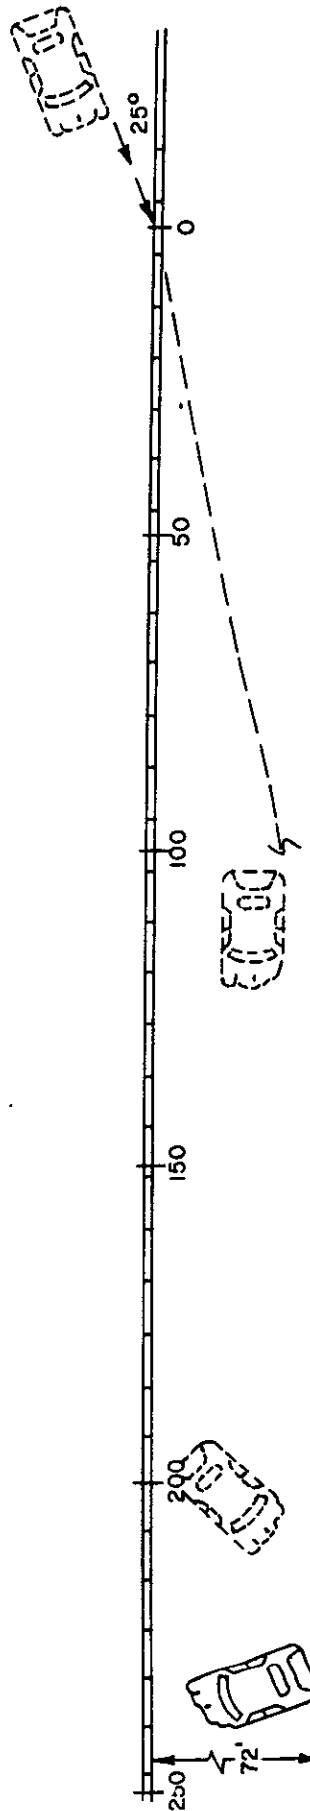
FENCE DAMAGE \_\_\_\_\_ 345' Damaged--Cable anchor behind impact pulled from ground & moved 56'  
 CABLE DAMAGE \_\_\_\_\_ Slight fraying--Turnbuckles bent  
 POST DAMAGE \_\_\_\_\_ 27 posts damaged beyond repair  
 POST ANCHOR DAMAGE \_\_\_\_\_ 5 additional anchors cracked  
 MAX. DEFLECTION OF CABLES \_\_\_\_\_ 72'  
 VEHICLE DAMAGE \_\_\_\_\_ \$400

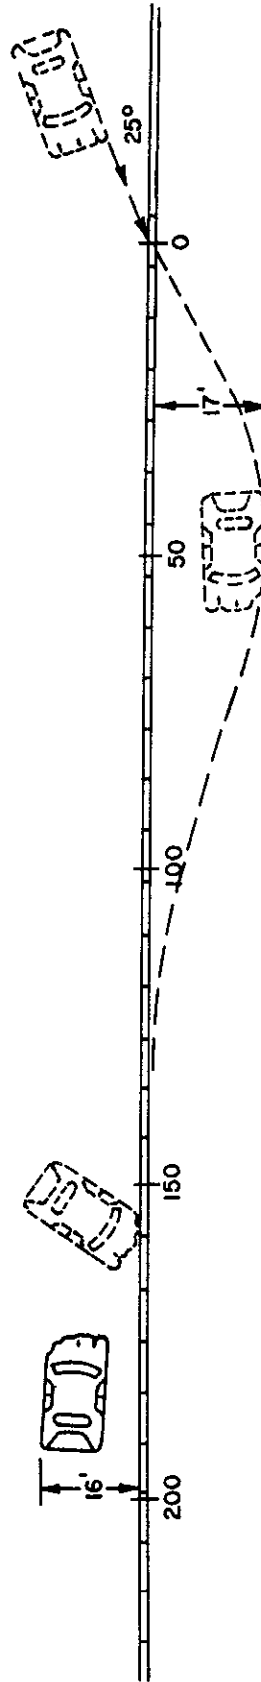
**BARRIER DAMAGE** (see Exhibit 11): 29 posts bent beyond repair. Turnbuckles were bent requiring replacement of two studs. Cables were frayed slightly (loss of less than 25% of cross section) requiring installation of a preformed patch rod kit on the damaged section before Test No. 4 (see Exhibit 12-A and B).

FENCE ----- No Fabric  
 CABLE ----- 3/4" 6x19 IWRC (2 @ 30" above pvmt.)  
 POST ----- 2 1/4" x 4 1/2" x 88" Std. H Post  
 POST ANCHOR ----- Type B  
 POST SPACING ----- 8' O.C.  
 LENGTH OF INSTALLATION ----- 500'  
 GROUND CONDITION ----- Dry

FENCE DAMAGE ----- 225' damaged - Cable anchor loosened but not pulled from ground - Turnbuckles bent  
 CABLE DAMAGE ----- Slight fraying  
 POST DAMAGE ----- 29 posts bent beyond repair  
 POST ANCHOR DAMAGE ----- No additional damage  
 MAX. DEFLECTION OF CABLES ----- 17'  
 VEHICLE DAMAGE ----- \$400

TEST NO. ----- 3  
 DATE ----- 8-22-62  
 VEHICLE ----- 1960 Dodge Sedan  
 SPEED ----- 84 MPH  
 IMPACT ANGLE ----- 25°  
 VEHICLE WEIGHT ----- 4300 lbs (W/Dummy & instrumentation)

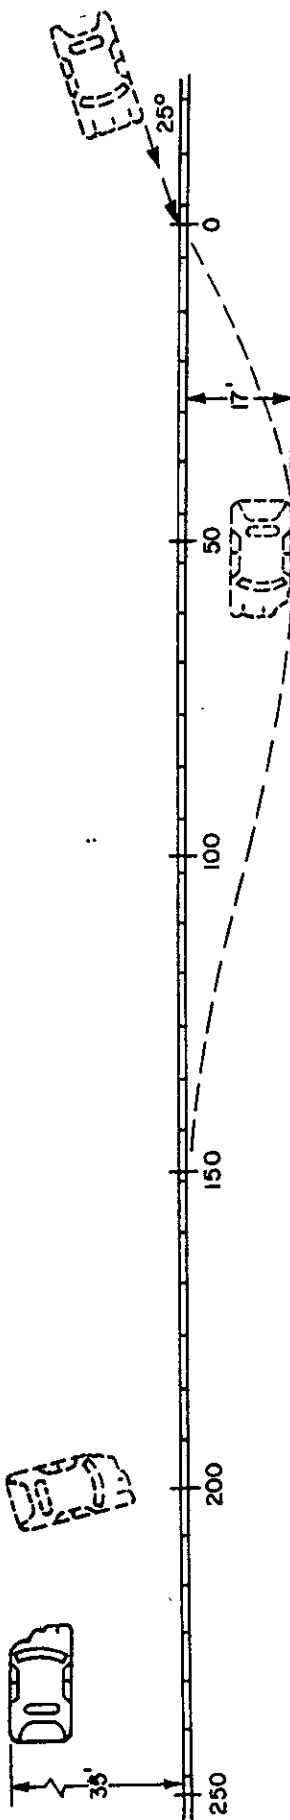
BARRIER DAMAGE (see Exhibit 12): 27 posts were bent beyond repair, and 1 post pulled out. The preformed splice was damaged beyond repair, but there was no further damage to the cable.

TEST NO. \_\_\_\_\_ 4  
 DATE \_\_\_\_\_ 8-30-62  
 VEHICLE \_\_\_\_\_ 1960 Dodge Sedan  
 SPEED \_\_\_\_\_ 87 MPH  
 IMPACT ANGLE \_\_\_\_\_ 25°  
 VEHICLE WEIGHT \_\_\_\_\_ 4300 lbs  
 (W/Dummy & Instrumentation)

FENCE DAMAGE \_\_\_\_\_ 216' Damaged  
 CABLE DAMAGE \_\_\_\_\_ No further fraying—Splice damaged  
 beyond repair  
 POST DAMAGE \_\_\_\_\_ 27 posts bent beyond repair  
 POST ANCHOR DAMAGE \_\_\_\_\_ No additional damage  
 MAX. DEFLECTION OF CABLES \_\_\_\_\_ 17'  
 VEHICLE DAMAGE \_\_\_\_\_ \$ 400

FENCE \_\_\_\_\_ No Fabric  
 CABLE \_\_\_\_\_ 3/4" 6x19 IWRC (2 @ 27"  
 above pvm) Rejoined w/preformed splice  
 POST \_\_\_\_\_ 2 1/4" x 4.1# x 69" Std. H Post  
 POST ANCHOR \_\_\_\_\_ Type B  
 POST SPACING \_\_\_\_\_ 8' O.C.  
 LENGTH OF INSTALLATION \_\_\_\_\_ 500'  
 GROUND CONDITION \_\_\_\_\_ Dry
